RESIDENTIAL INSPECTION

16930 N 280 Rd Morris, OK 74445

> Brent Wellings NOVEMBER 30, 2023

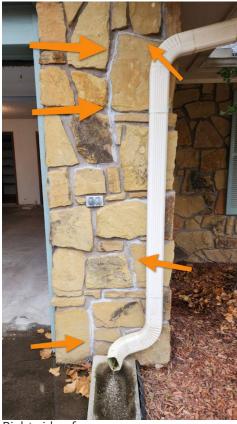
Right side of garage

MORTAR CRACKING DETERIORATING

Deteriorated or cracked mortar joints were noted in one or more areas of the brick veneer or stone siding transition. This is common over time and is typically the result of long term settlement. Recommend removal and point and tucking the mortar in these areas.

Contact a qualified masonry professional.

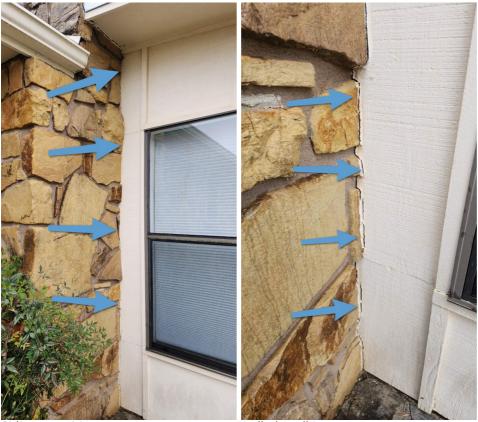
Siding transition

3.2.2 Siding, Flashing, Trim, Soffit, & Facias CAULKING SUBSTANDARD/MISSING SUNROOM SIDING TRANSITION

Routine Maintenance: At the time of inspection, caulk was missing, deteriorated or substandard in some areas, like around windows or doors, at siding butt joints, at siding-trim junctions, or at wall penetrations. The Inspector recommends that the affected area(s) re-caulked by a professional contractor.

Pulled caulking

Contact a handyman or DIY project

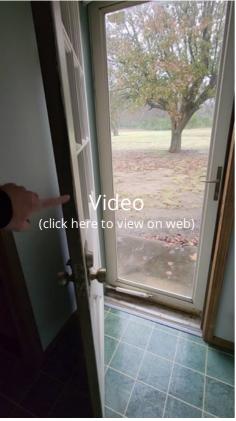
Back left exterior door

One or more exterior doors would not stay open on it's own. This is caused by the door not being hung plumb or falling out of plum over time. A simple fix is to remove the door hinge pin and hammer it on a concrete surface a few times to add a slight bend to the door pin. Reinstall the door pin. This slight bend will cause a minor bit of friction in the hinge, allowing the door to stay open. If this does not work with one hinge, keep trying on all 2-3 hinges till door stays open.

Contact a qualified general contractor.

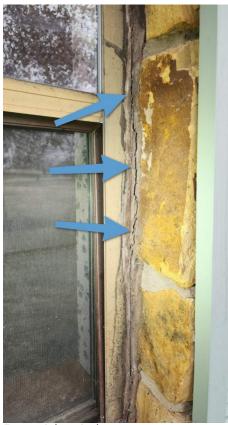
Front right window

3.6.1 Windows
DETERIORATED/ MISSING CAULK

Routine Maintenance: The caulking around one or more exterior windows was deteriorated and or missing. We recommend properly sealing. Exterior caulking is the first energy efficient measures to install. The purpose of exterior caulking is to minimize air flow and moisture through cracks, seams, utility penetrations and openings. Controlling air infiltration is one of the most cost effective measures in modern construction practices, a home that is not sealed will be uncomfortable due to drafts and will use about 30% more heating and cooling energy than a relatively air-tight home. In addition, good caulking and sealing will reduce dust and dirt in the home and prevent damage to structural elements.

Recommendation Contact a handyman or DIY project

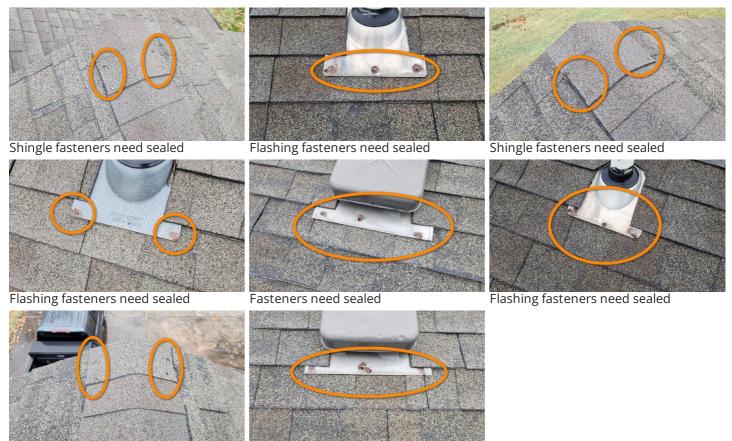
Exposed/poorly sealed nail heads were noted at the roof flashing and/or ridge shingles or head walls. Exposed/poorly sealed nail heads can allow water to penetrate past the roof covering given enough time. As the exposed portion of the nail rusts, more space will become available between the nail and the roofing material for water to penetrate. This condition can usually be remedied by sealing or caulking affected areas an exterior grade sealant. The inspector recommends ensuring all exposed nail heads are adequately sealed.

Shingle fasteners need sealed

Flashing fasteners need sealed

Contact a qualified roofing professional.

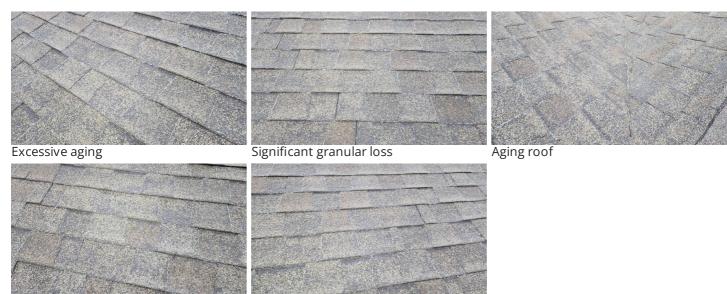
Example photo

The roof in it's current condition, showed excessive signs of aging including but not limited to: Granual loss, craze cracking, significant or excessive wear and tear, hail, or displayed areas in need repairs.

Aging roof

The inspector recommends having the roof further evaluated by a licensed roofing contractor.

Contact a qualified roofing professional.

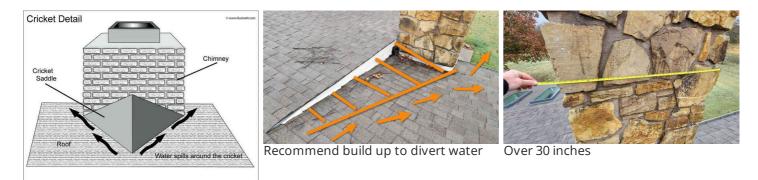
CRICKET MISSING

The chimney had no cricket installed. A cricket is a small section of roof built on the uphill side of a chimney to prevent rain and snowmelt from pooling and causing damage from roof leakage. Crickets are recommended for chimneys measuring 30 inches wide or more. This condition may result in premature failure of roofing in this area and/or damage to home materials or personal belongings from moisture intrusion. We recommend you consult with a professional roofing contractor to discuss options and costs for correction.

41 to 42 inches wide

Contact a qualified roofing professional.

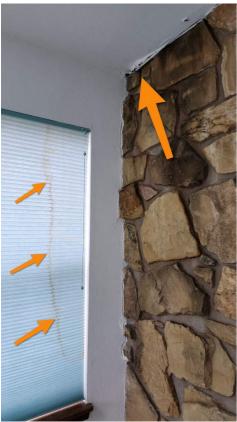
Base of chimney

We noted gaps in one or more areas of flashing that will allow moisture intrusion into the decking, attic or home. Flashings should have no gaps/voids and be installed in a way that routs water away from the flashed area. Recommend sealing this gap to minimize the possibility of moisture intrusion.

Evidence of moisture below gap

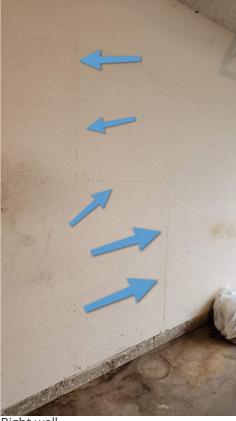
Right wall

SETTLEMENT CRACKING/EVIDENCE OF SETTLEMENT GARAGE

Settlement cracking, drywall seam cracking of other evidence of settlement was noted was noted in one or more areas of the garage. These can be attributed to long term settlement of the home. Recommend having repaired as needed.

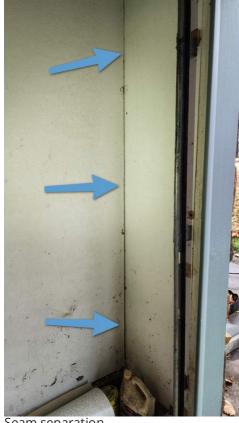
Seam separation

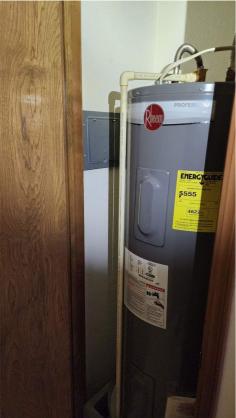
SUB PANEL

We noted a In a electrical panel that did not have adequate work space clearance. Standards require a clear area for access and working in front of an electric panel at least 36 inches in depth. The work space shall not be less than 30 inches wide in front of the electrical equipment and not less than the width of the equipment. For this reason, the panel cover could not be safely removed. No comments can be made to the interior condition of this panel.

Inadequate work space clearance

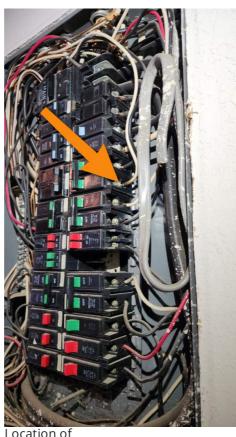
Location of

Heat damage noted

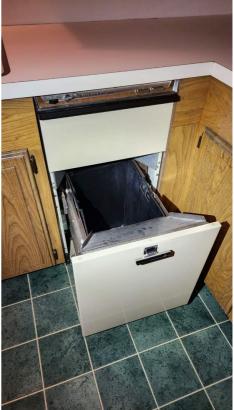
Trash compactor

Not functional at the time of the inspection.

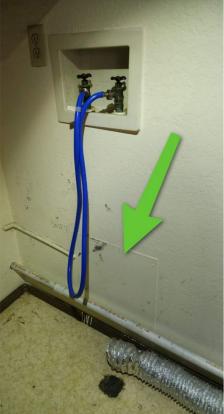
Below washer connections

Washer Connections: Evidence of Previous Repairs

We noted evidence of previous repairs underneath the washer box in the laundry room. Although no moisture was present, these repairs are typically the result of a previous water leak. We recommend consulting the seller around the nature of these repairs. No comments can be made to the conditions of the wall structure on the other side of these repairs. Evaluation of the area would require removing the drywall patch is falls outside the scope of a limited, visual home inspection.
