RESIDENTIAL INSPECTION

16930 N 280 Rd Morris, OK 74445

> Brent Wellings NOVEMBER 30, 2023

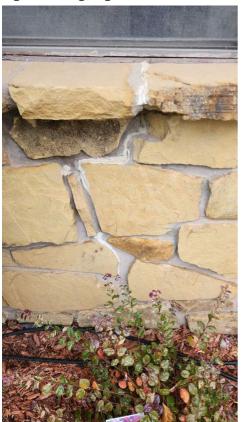
Right side of garage

Deteriorated or cracked mortar joints were noted in one or more areas of the brick veneer or stone siding transition. This is common over time and is typically the result of long term settlement. Recommend removal and point and tucking the mortar in these areas.

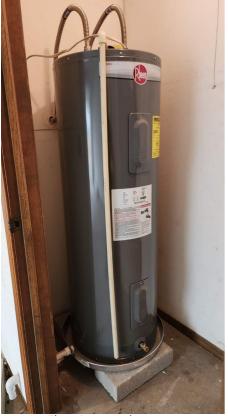
Located in garage closet

2016 model

Water heaters have a typical life expectancy of 9 to 12 years. The existing unit was approximately half way or more to this age range. One cannot predict with certainty when repairs or replacement will become necessary. Regular maintenance and inspections are advised.

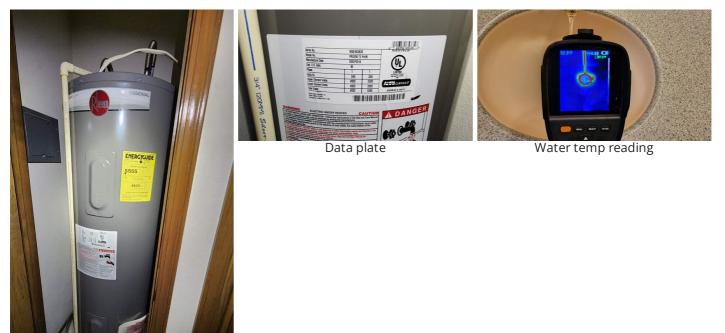
Located in laundry room closet

Electric water heater

2016 model

Water heaters have a typical life expectancy of 9 to 12 years. The existing unit was approximately half way or more to this age range. One cannot predict with certainty when repairs or replacement will become necessary. Regular maintenance and inspections are advised.
